MSP430G2452 Device Erratasheet

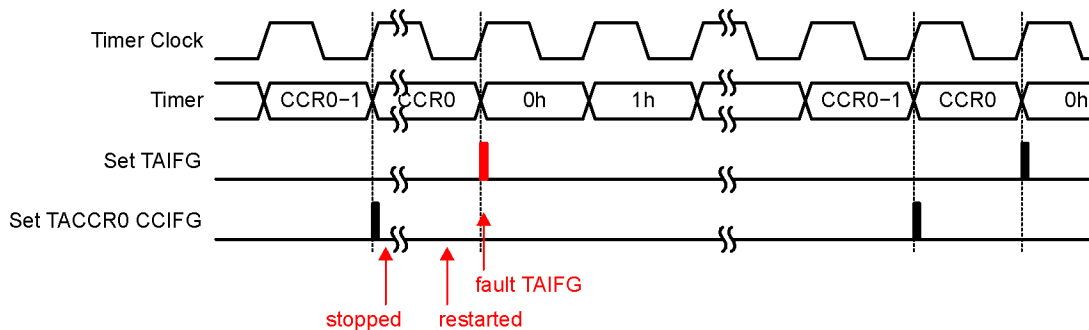
TA21 *TIMER_A Module*

Function TAIFG Flag is erroneously set after Timer A restarts in Up Mode

Description In Up Mode, the TAIFG flag should only be set when the timer counts from TACCR0 to zero. However, if the Timer A is stopped at TAR = TACCR0, then cleared (TAR=0) by setting the TACLR bit, and finally restarted in Up Mode, the next rising edge of the TACLK will erroneously set the TAIFG flag.

Workaround None.
